A Summary of Potential Geologic Hazards in Holmes Run Valley in the Landmark Area, Alexandria, Virginia

Prepared by Anthony H. Fleming, LPG, February 8, 2022

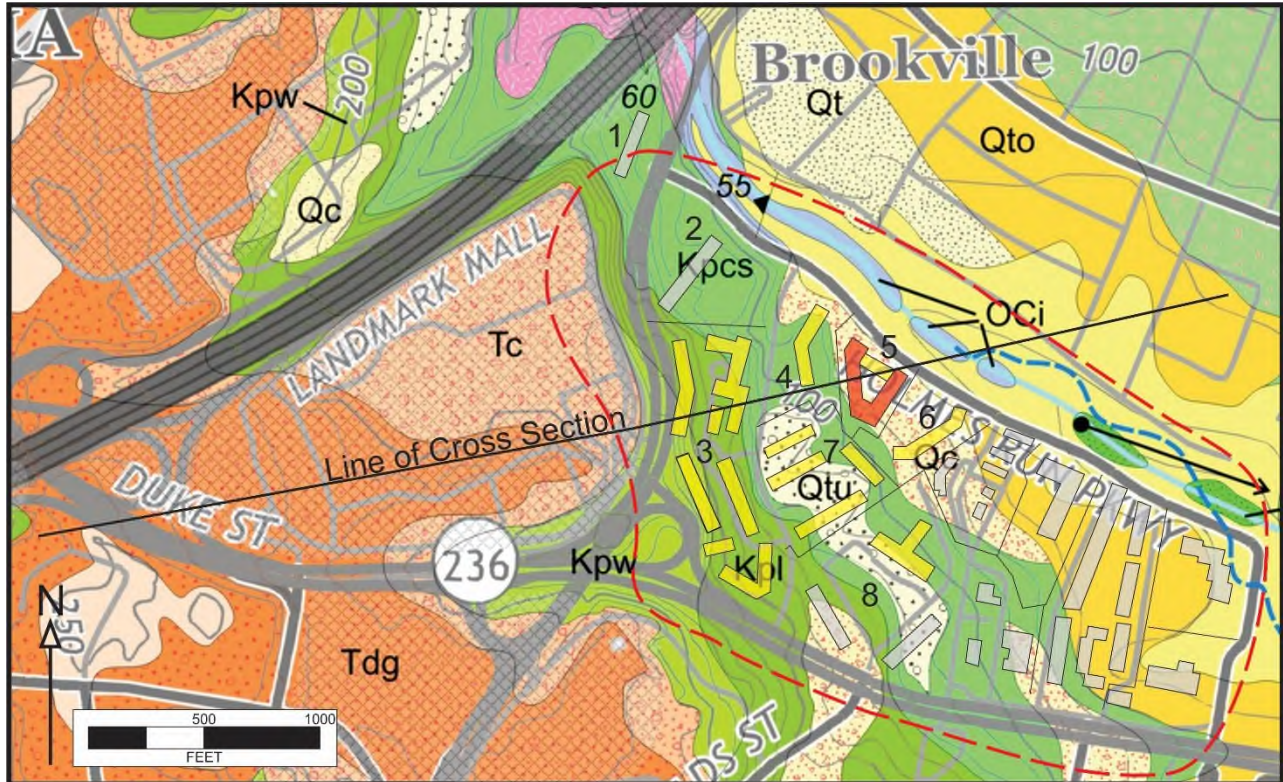
Figure 1. Geologic map of the site (outlined in red) and its surroundings. Site geology is best thought of as a series of alternating layers of clay and sand (or gravel) with strongly contrasting properties in terms of slope stability, shrink-swell potential, ability to transmit groundwater, and other parameters. Three members of the Potomac Formation (green colors) are of particular importance: The steep upper slopes are underlain by the unstable Lincolnia silty clay (Kpl), which is a major landslide-maker in this part of the City. This unit is interbedded at places with Winkler sand (Kpw), which commonly contains a perched water table that acts to soften and wet the enclosing clay. Lower slopes are developed on the Cameron Valley sand (Kpcs), a thick, water-bearing sand and gravel body at the base of the formation that makes up the regionally significant lower Potomac aquifer. Hillsides are frequently blanketed by landslide debris and a variety of loose, gravelly colluvium (Qc), along with terrace deposits of ancestral Holmes Run (Qtu). A sheet of old, orange-weathering river gravel (Tdg, Tc) underlies the upland to the west, while the bottomland along Holmes Run consists of saturated sandy alluvium (Qa) deposited recently by Holmes Run along with several slightly higher, generally sandy or gravelly stream terraces (Qt, Qto). The cross-section line indicates the location of figure 6.

Parcview Apartments is identified as building 5 on the map. It currently consists of a 14-story high rise constructed in 1974 (shown in yellow) on a lot of about 3 acres. The proposed construction project would add two attached, 9-story wings (orange on map), each with a two-story subterranean parking garage, resulting in an overall, southwest-pointing “V” shaped structure around the original building. Neighboring buildings identified by numbers on the map are: 1) Broadstone on Van Dorn, 9 stories, built in 1964; 2) Place One, a 15-story high rise tower built in 1974; 3) The Assembly (formerly Barton’s Crossing), 4-5 stories, built in 1989; 4) Claridge House, 12 stories, built in 1981; 6) Pavilion on the Park, 15 stories, built in 1967; 7) 101 North Ripley, 3 stories, built in 1963; and 8) London Park Towers, 15 stories, built in 1963. Each of these structures may be exposed to some level of risk resulting from the alteration of subsurface geology, groundwater flow patterns, and slope forces by the proposed construction and potential acceleration of existing geologic hazards.

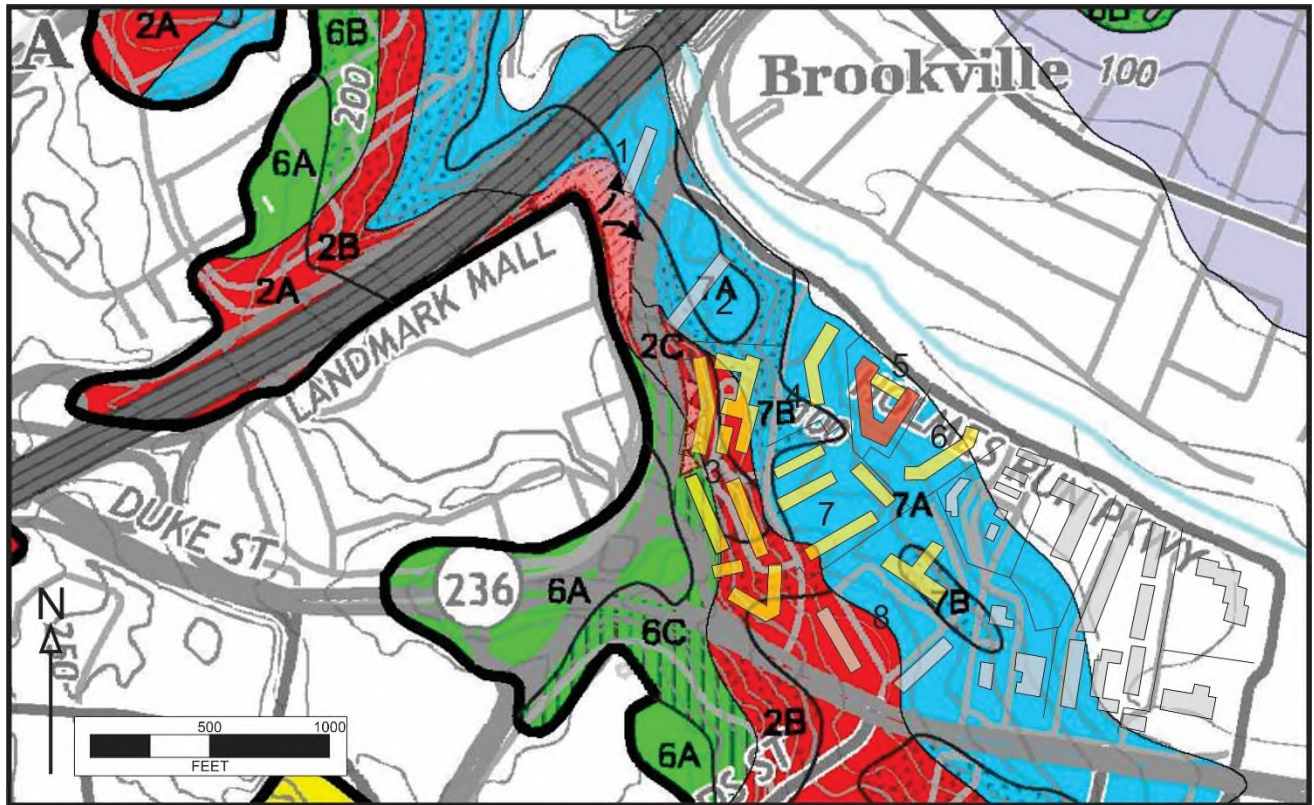
Figure 2. Landslide susceptibility map of the site and its surroundings. The upper slopes (red) are characterized by highly expansive soils and are demonstrably susceptible to slope failures, with much of the area in the most vulnerable slope steepness classes (units 2B and 2C). Recently active landslides are visible above Broadstone at Van Dorn (1) and elsewhere, while a geotechnical report on file with the city details efforts to remediate slope failures at The Assembly (3) shortly after its construction. Map unit 7 (blue), which makes up the lower part of the slopes, is less susceptible to landslides, mainly due to lesser clay content and slope steepness, but the geology is sufficiently variable (e.g., unpredictable silt-clay lenses) that disturbances to terrain or hydrology can trigger localized problems such as differential shrink-swell and instability.

1) The slopes at this site have naturally evolved over many thousands of years by hillside creep, landslides, and other mass wasting processes, with the lower slopes generally acting as repositories for material shed from the upper slopes. These processes occur exceedingly slowly and/or infrequently under natural conditions but have been accelerated at this site and elsewhere in the general area due to past disturbances, including development of hillsides, emplacement of artificial fill and infrastructure at the crowns of slopes, and removal or cutting of toeslopes that provide a bulwark against strong lateral earth forces emanating from upslope. Further, the geologic formations and their particular arrangement at the site create virtually every aggravating condition described by Stephen Obermeier³ in his comprehensive analysis of slope stability in northern Virginia. While the proposed building site does not itself appear to lie within unstable clay, judging from the elevations presented in the site plan the proposed construction does contemplate cutting and removing the toeslope at the back of the site, which is a well-known trigger for slope failures further upslope.

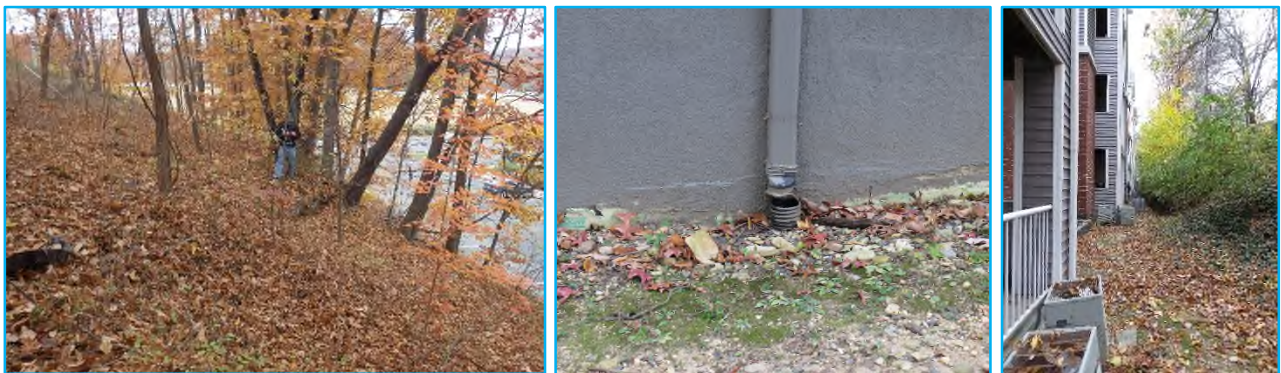
Figure 3. Evidence of enhanced downslope creep is visible throughout the slopes at the site, including leaning trees with an upwards-bending growth habit (left), displaced drain connections (center), and out-of-plumb buildings and tilted infrastructure components (right). In this unstable geologic setting, cosmetic damage to buildings may presage more serious long-term structural issues that typically appear years later. The risk of slope failures is heightened by disturbances to terrain, notably the loading of the crowns of slopes with infrastructure or artificial fill and the cutting of toeslopes for building foundations and streets. All of these risk factors are already present at the site.

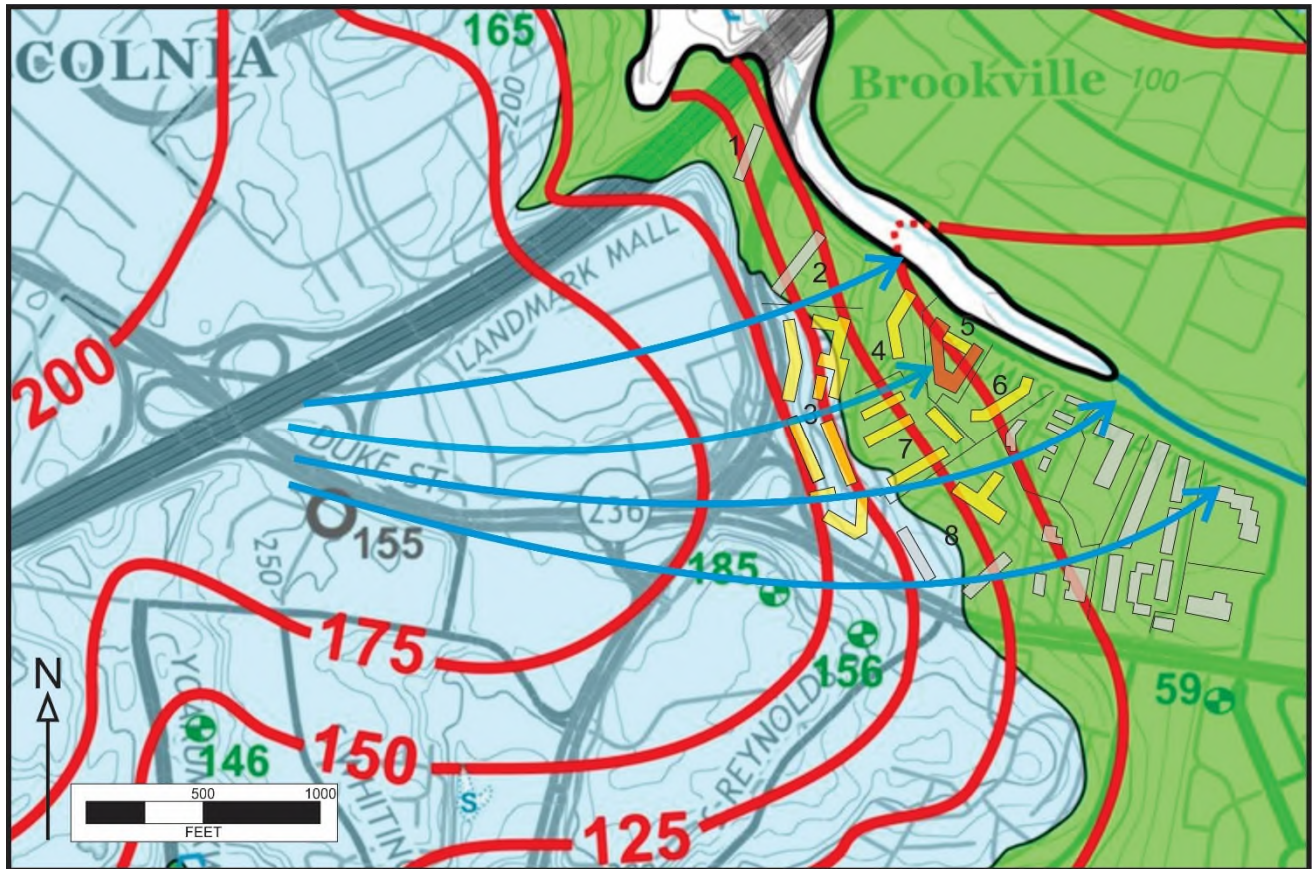
Figure 4. Water levels in the lower Potomac aquifer at the site and its surroundings. Heavy red contours are lines of equal water level elevation in the aquifer. The aquifer is under artesian conditions (water levels above the top of the aquifer) in the light blue area, and under water table conditions (water levels below the top of the aquifer) in the green polygon. The contours indicate that water levels slope sharply eastward across the site from the recharge area to the west. Blue arrows show the general direction of groundwater flow under the site. These relations indicate that: 1) a large volume of groundwater is moving into and under the site, which is expected to produce sizable hydrostatic force against subsurface objects (such as a foundation wall) installed below the water table; 2) the saturated thickness of the aquifer decreases downgradient as the aquifer becomes thinned by erosion. This is expected to lead to a shallow water table at the proposed building site and adjacent areas, in order to accommodate the same volume of groundwater through a thinner saturated thickness of aquifer; and 3) groundwater velocity is likely quite high beneath the site, again to transmit the same volume of groundwater through a progressively thinner section of aquifer.

The current proposal is for a two-story subterranean parking garage beneath both Parcview additions; such a structure will almost certainly extend vertically through the entire saturated thickness of the aquifer and into the underlying (largely impermeable) crystalline bedrock, thereby creating a major obstruction to groundwater flow and imposing large, permanent dewatering costs to maintain dry conditions in the parking facility. Interrupting groundwater flow or altering subsurface moisture conditions could create or exacerbate a number of issues, such as: more frequent surface collapses (“sinkholes”), which are currently present in the lower parts of the site and may be associated with buried ravines or infrastructure such as sewers or the old millrace, and are likely exacerbated by groundwater erosion; development of a groundwater mound on the upgradient side of the obstruction, leading to even greater hydrostatic forces on the structure itself, surrounding foundations, and adjacent sections of the hillside, including unstable clays; and increased groundwater velocity adjacent to the obstruction to compensate for loss of aquifer volume.

2) The building project proposes to install a two-story underground garage that, based on nearby outcrops along Holmes Run, will extend completely through the lower Potomac aquifer and into the top of the underlying crystalline bedrock, which is typically of much lower permeability and functions as a lower flow boundary for the aquifer. Moreover, the long axis of the new building/garage lies at a right angle to the direction of groundwater flow. When completed, the subterranean part of the building will create a monolithic barrier that obstructs the flow of groundwater across most of the width of the Parcview parcel. This could create a number of hydrologic challenges: a large amount of hydrostatic force is expected to be directed against the building/garage foundation on the upgradient side; the need to maintain a substantial and permanent dewatering operation to prevent the garage from filling up with groundwater; the dam-like effect of the subsurface structure is likely to create a groundwater mound on the west side of Parcview, raising water levels and pressure at adjacent properties and possibly on the adjacent unstable slopes; faster groundwater flow velocities in adjacent areas as water is forced to flow around this obstruction; on the other hand, continuously removing a large volume of groundwater via dewatering could create other unintended consequences, such as subsidence, more frequent surface collapses, or differential settlement or shrink-swell of clay-rich zones in response to a new moisture regime.

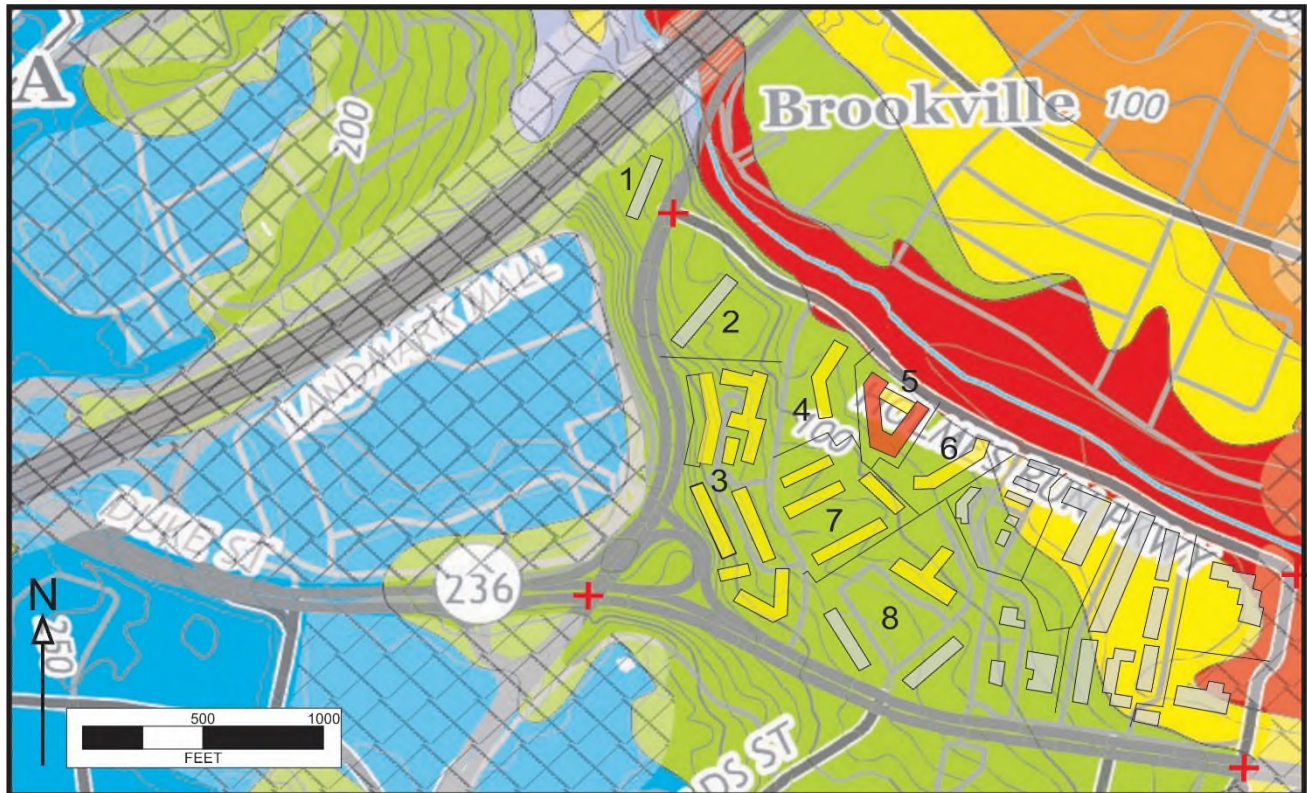
Another hazard that closely corresponds to water table depth is the potential for amplification of seismic waves and liquefaction of saturated sediment, leading to a loss of bearing strength. Damaging seismic waves may be generated by moderate to strong earthquakes in the Central Virginia Seismic Zone, such as the one that occurred in 2011 and was strongly felt by more than 1,000 Alexandria residents², or from more local sources of seismic energy, such as pile driving or other construction activities, which tend to produce smaller and more localized effects whose extent and strength depend greatly on local geologic conditions.

Figure 5. Map of the site and its surroundings showing estimated relative potential for amplification of seismic waves in relation to surficial geology. The red polygon along Holmes Run and Holmes Run Parkway consists of sandy alluvium with a shallow water table, a condition favorable to amplification of seismic waves and prone to liquefaction upon strong shaking. Yellow and green polygons have low to moderate abilities to amplify seismic waves and generally low liquefaction potential unless the water table is shallow, in which case liquefaction potential may be higher. Major areas of artificial fill are indicated with a mesh overlay and have the potential to rank at or near the top of the scale for amplification of seismic shaking, depending on their composition, how well they were compacted when emplaced, water table depth, and other factors. Additional areas of artificial fill too small to show at the map scale are likely present at the site, especially in the lower-lying areas closer to Holmes Run. In short, the potential for seismic wave amplification is exquisitely dependent on local near-surface geologic conditions, which can vary greatly across short distances in a highly altered landscape like Alexandria's.

3) Conditions in the lower part of the site close to Holmes Run Parkway appear conducive to the amplification of seismic waves derived either from earthquakes or construction activities such as pile driving. Wet alluvial soils and artificial fill in this part of the site are potentially prone to liquefaction when subjected to strong shear waves.

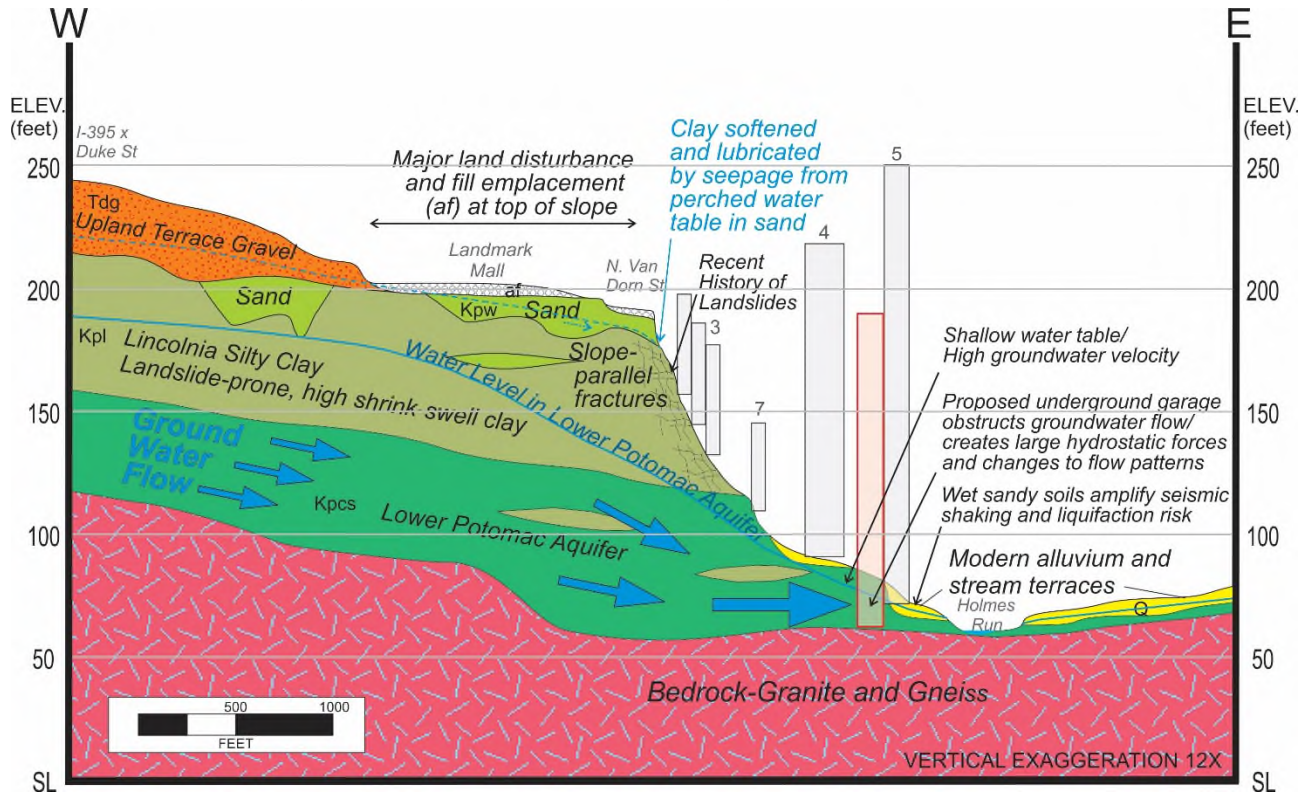
Figure 6. Geologic cross section of the site and its surroundings. Cross sections are like a vertical slice through the subsurface and provide a perspective of the geologic formations, topography, and other features in the third dimension. Geologic map units are generalized from fig. 1, while the water level in the lower Potomac aquifer is the vertical representation of the contours in fig. 4. Silhouettes of existing buildings along the cross-section line are in gray; their foundation details are unknown. The profile of the proposed Parcview addition is in red and shows the 2-story underground parking facility extending to the minimum depth needed to accommodate both levels. Building numbers correspond to fig. 1. Note that the latest FEMA flood map indicates that the base flood elevation of Holmes Run at this location would completely inundate the lower level of the belowground parking facility and potentially some of the higher level.
